# Technical Information

## Stoll Frontlader

### Grading

TI-2.3-05-02\_EN

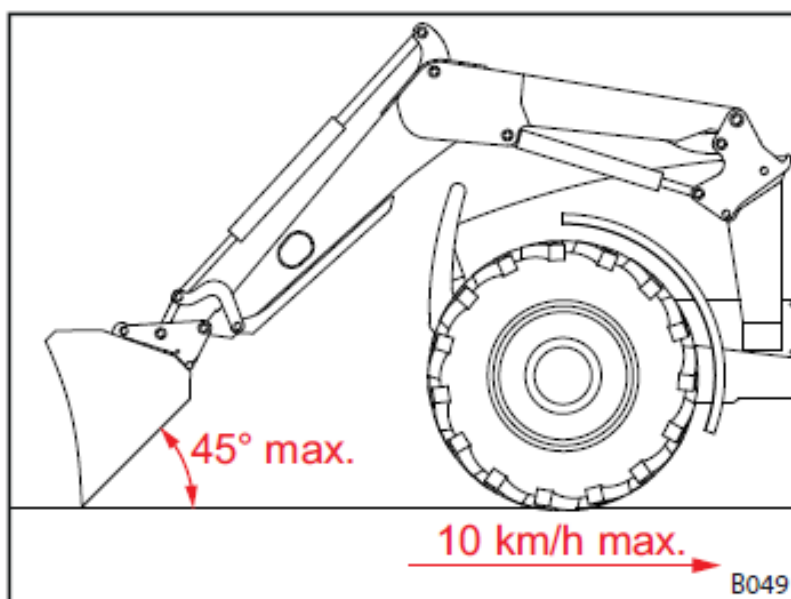
- **Grading only with the bucket lip, not with the bottom of the bucket**
- **The angle between the bucket and the ground must not exceed 45°**
- **Driving direction backwards only**
- **Maximum speed: 10 km/h**

Scope:	STOLL front loaders
Symptom:	Bent reversing levers, damaged implement cylinders,
Possible cause:	Grading not carried out correctly

It is important to follow the instructions in the operating instructions. The right setting angle of the implement and the right direction of travel are important factors for ensuring the long service life of the front loader.
